Post-War Building Damage Detection [†]

Abstract: Natural disasters and wars wreak havoc not only on individuals and critical infrastructure, but also leave behind ruined residential buildings and housings. The size, type and location of damaged houses are essential data sources for the post-disaster reconstruction process. Building damage detection due to war activities has not been thoroughly discussed in the literature. In this paper, an automated building damage detection technique that relies on both pre- and post-war aerial images is proposed. Building damage estimation was done using shadow information and Gray Level Co-occurrence Matrix features. Accuracy assessment applied over a Syrian war-affected zone near Damascus reveals the excellent performance of the proposed technique.

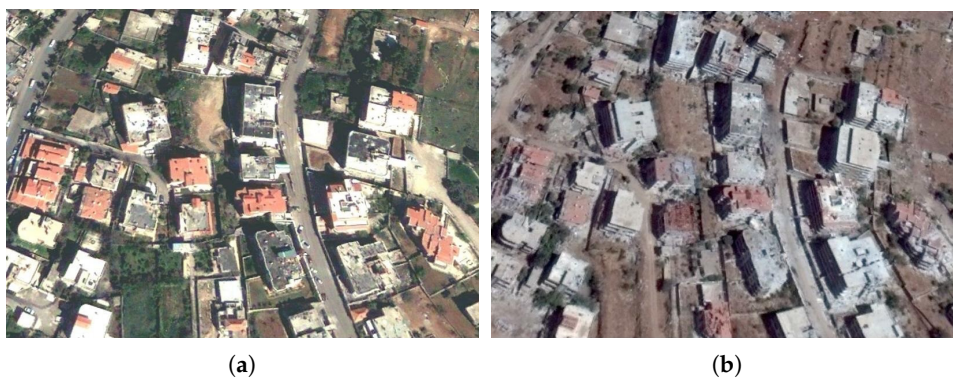
Figure 2. (a) pre-war; and (b) post-war original images for Zabadani Study Area.

The literature does not provide, to the best of our knowledge, a relevant dataset for war affected areas to benchmark against. Thus, we focused in this work on images taken in 2015 during the Syrian civil war for Zabadani region near Damascus. Figure 2a,b depicts the pre- and post-war original images captured on 18 May 2015 and 5 August 2105, respectively, using GeoEye-1.

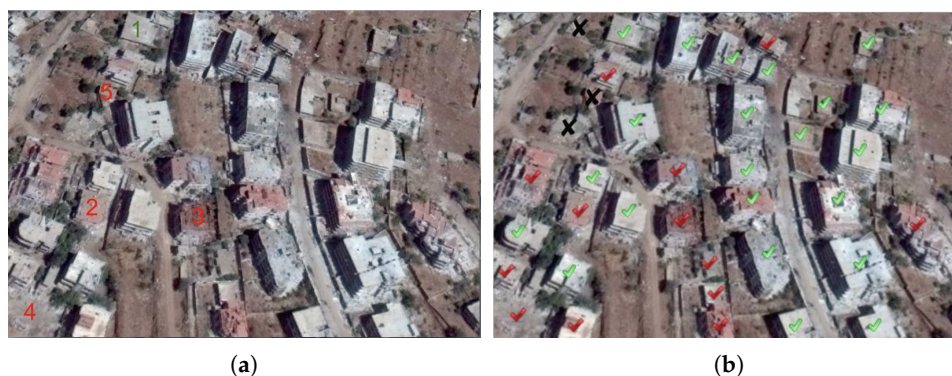
Figure 3. (a) Five labeled buildings investigated in details in Table 1; and (b) shows building damage assessment results of the proposed algorithm.

Table 1 shows the values for *SAD*, *VD* and *CD*, respectively, for five buildings labeled in Figure 3a (post-war Zabadani Study Area). Damaged buildings are labeled using red color, while normal ones are labeled using green. Results for remaining buildings are omitted due to space limitation.

For Building 4, no shadow is detected in the post-war image and thus the relative building is considered as totally damaged. Generally, normal buildings have high spatial relation between their gray levels in addition to higher homogeneity, and vice versa. Therefore, normal buildings Variance and Correlation values are higher than those of damaged buildings. Building 5 is misclassified as a normal building due the absence of noticeable major structure deformation in the post war image, thus having low *VD* and low *CD* values.

Figure 3b shows the resultant image of applying proposed building damage detection algorithm on Zabadani study area, where truly detected normal buildings are labeled with a green tic-mark, truly detected damaged buildings are labeled with a red tic-mark, and undetected damaged buildings are marked with a black cross. Table 2 shows the accuracy assessment results for the proposed building damage detection algorithm using three metrics defined as follows:
